Manhole Inspection Summary

Manhole # S45E2_016MH

Insp Date: **2/26/08 8:19 AM**

Location Address: **4101 Fairhaven Ave** Cross Street: **Plum-Olmstead**

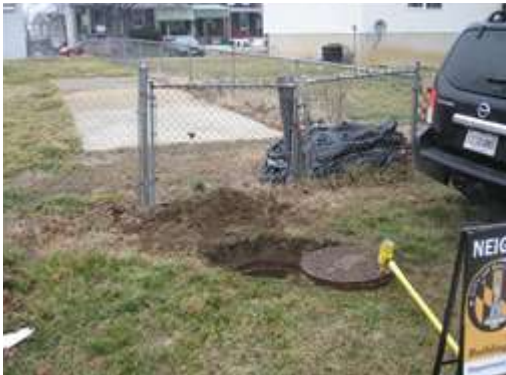
Location View

Plum-Olmstead

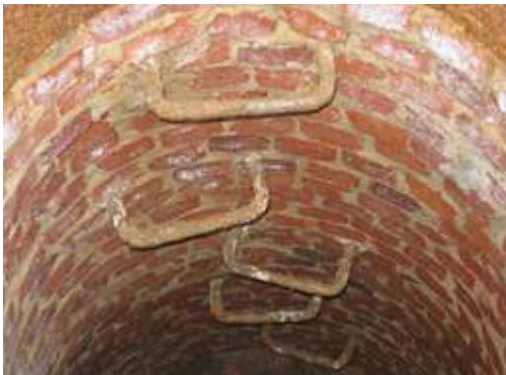
Steps Count: **5** Missing: **0** ☐ Corroded

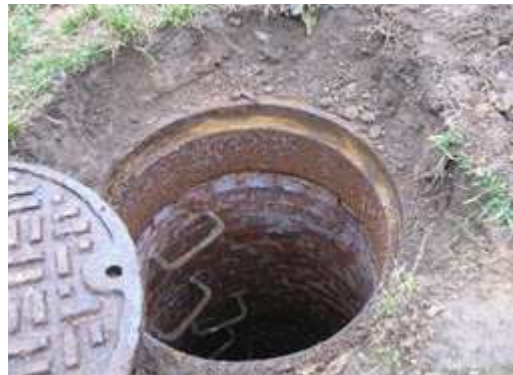
Defect 2

Manhole under grade

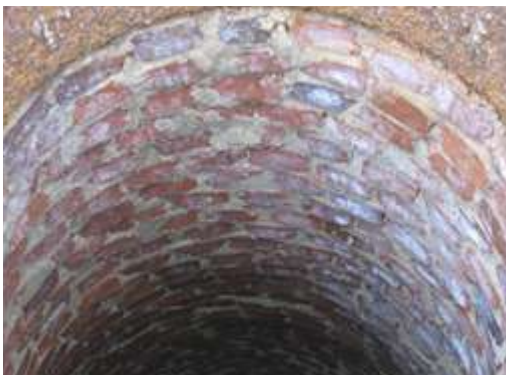
Defect 1

Corbel Material: **Brick** ☐ Parged Type: **Concentric/Eccentric**
Condition: ☒ Sound ☐ Cracked ☐ Root Intrusion ☐ Loose Brick ☐ Deteriorated
Infiltration: ☐ None ☐ Joint ☐ Cracks ☒ Mortar ☐ Roots ☐ Wall

Mortar

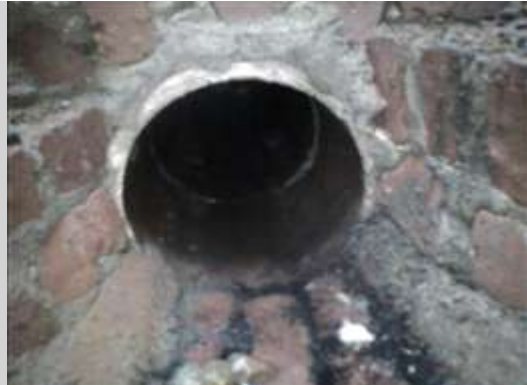
12 O'Clock Outflow

8 in. Circular Gravity Sewer
Pipe Out @ 12 O'Clock

Pipe Height: **9.6** (in.) Rod and Bar (Angled)
Pipe Material: **Clay** ☐ Pipe Lined
Invert Depth: **8.66** (ft.) Flow Characteristics: **Fast**
Deposits: ☒ None ☐ Mud ☐ Sludge ☐ Debris ☐ Grease
Silt Depth: (in.) Deposits Extent:
Infiltration: **None** Pipe Seal Cond: **Sound**

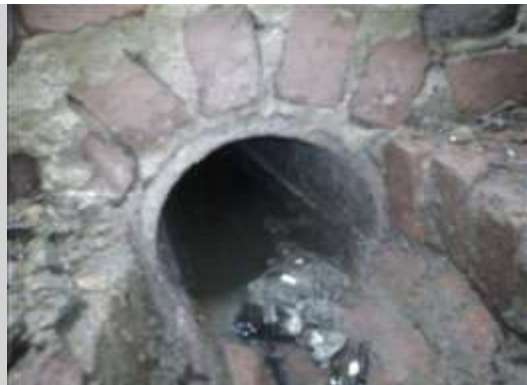
3 O'Clock Inflow

8 in. Circular Service Sewer
Pipe In @ 3 O'Clock

Pipe Height: **8.4** (in.) Rod and Bar (Angled)
Pipe Material: **Clay** ☐ Pipe Lined
Invert Depth: **8.60** (ft.) Flow Characteristics: **Fast**
Deposits: ☒ None ☐ Mud ☐ Sludge ☐ Debris ☐ Grease
Silt Depth: (in.) Deposits Extent:
Infiltration: **None** Pipe Seal Cond: **Sound**

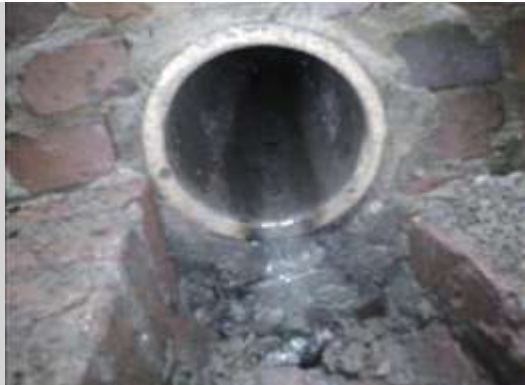
7 O'Clock Inflow

8 in. Circular Gravity Sewer

Pipe In @ 7 O'Clock

Pipe Height: **7.2** (in.) Rod and Bar (Angled)

Infiltration: **None** Pipe Seal Cond: **Sound**

Connects To: **Dead End**

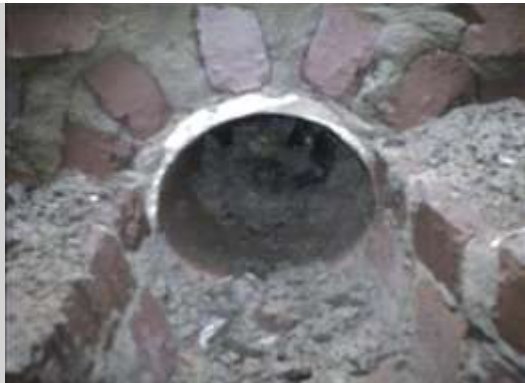
9 O'Clock Inflow

8 in. Circular Gravity Sewer

Pipe In @ 9 O'Clock

Pipe Height: **9.6** (in.) Rod and Bar (Angled)

Infiltration: **None** Pipe Seal Cond: **Sound**

Connects To: **Stub connection / abandoned**
